Ergonomic Vehicle Assessment

The Ergonomics Vehicle Assessment Investigation Process

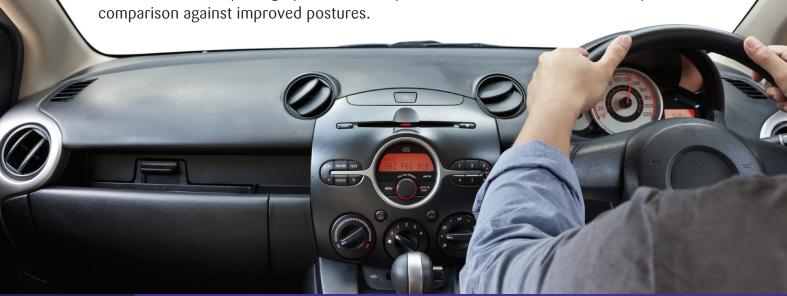
- 3. Task assessment of individual in their vehicle. Data collection such as video, photographs, anthropometric measurements and vehicle adjustments were collected. Ergonomist collected videos and photographs of current postures which were used within report for comparison against improved postures.

Audit of the vehicles seat and steering column adjustments were completed. Anthropometric measurements of the individual were taken to compare against adjustments offered by vehicle.

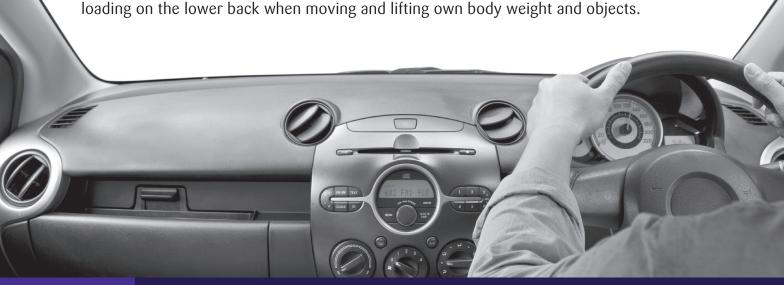
Issue 3 - Non neutral spinal postures adopted during manual handling of goods from vehicle

Recommendation - Provide advice around adopting strong postures which reduce the loading on the lower back when moving and lifting own body weight and objects.
